Documenting the concepts of the 'Ecosystems Farm Management' approach

A farmer innovation report to Land & Water Australia and the Land Management Society

Geo & Hydro Environmental Management Pty Ltd

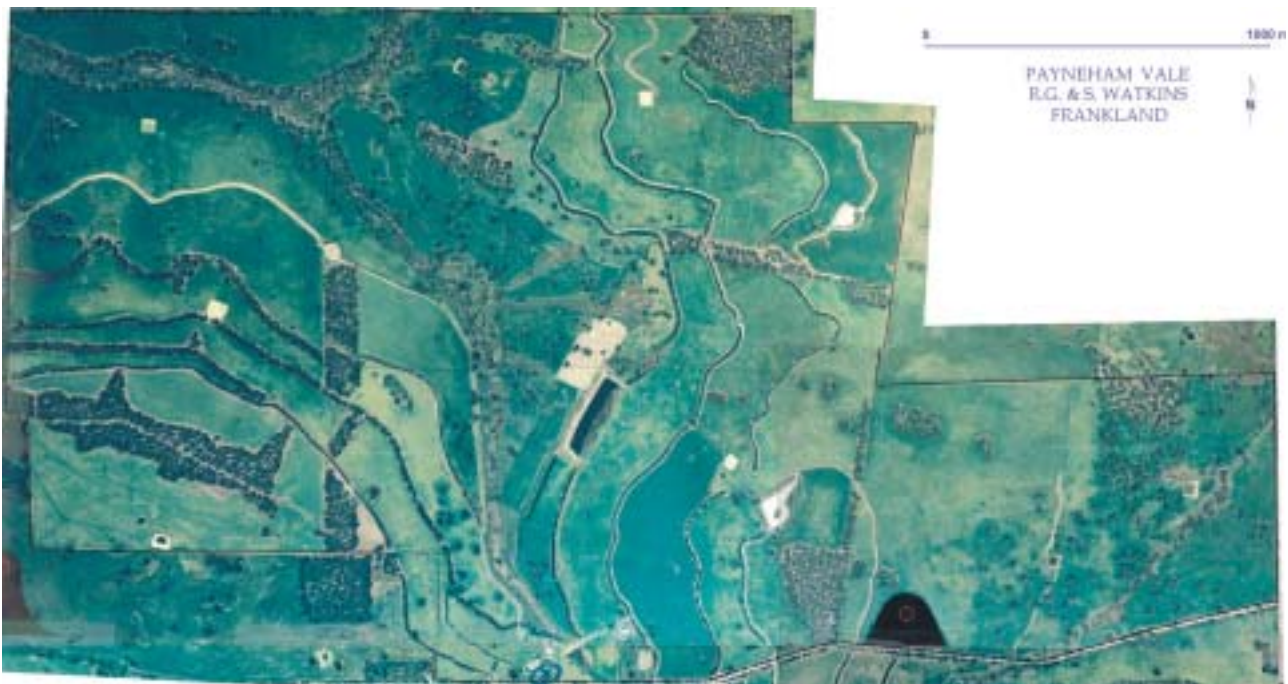
Figure 1. Image of Payneham Vale (October 1996). The Payneham Vale property is located on the headwaters of a tributary of the Frankland River in Western Australia. Drainage of the tributary generally proceeds to the north-west of the property, falling from divides at up to 310 m AHD (Australian height datum) to around 245 m in the creek channel in the north-west. The homestead, marked in blue near the bottom centre, is at around 285 m and located on Haynesdale Road at the lower centre of the image. The surface drainage from the property has been controlled with a series of banked channels. The channels have graded falls of around 1-in-300, usually leading water to the south-east corner of the catchment. They also have tree belts on their downslope side; these usually consist of four rows of trees across a 12 m width.

demonstrate considerable promise. Of these, the popular ‘ecosystem farm management’ system devised by Ron Watkins, and implemented on his own property, Payneham Vale (Figure 1), has been applied to approximately 70 farms. The system has been recognised by a United Nations Environment Programme (UNEP) Global 500 award for contributions to dryland farming. This project reviews the application of the ecosystem farm management system. It is a distinctive project in that it reviews a farm management system that has both developed inside the industry consultancy sector **and** received UNEP recognition.

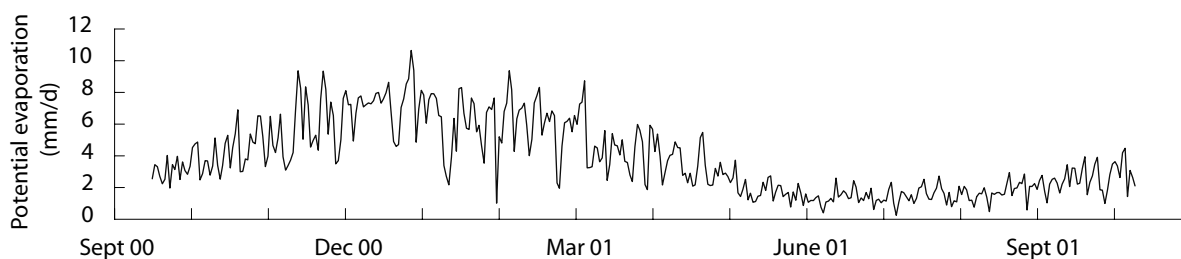
Figure 2. Potential evapotranspiration estimated from weather data recorded by an on-farm weather station. With a summer maximum of evaporation, the green perennial and deep-rooted vegetation has the capacity to remove substantial amounts of water, and will simultaneously draw salts to the considerable depth when the groundwater has been drawn down. Strategically, this is a relevant tool in recharge areas — particularly after these areas are minimised in their extent by the use of drains.

However, it must be recognised that seasons outside of these zones can occur. The year to 30 September 2001 had a potential ET of 1411 mm (Figure 2, main report) and rainfall of 431 mm. This gives a moisture availability of 31%, which is in zone 5 (Table A2.2). This is typical of a semi-arid, broadacre cropping zone, and it is not surprising to receive reports of good crops on Payneham Vale, but the outlook for summer vegetables was poor for 2001, because of low water stores in the dams on the property.

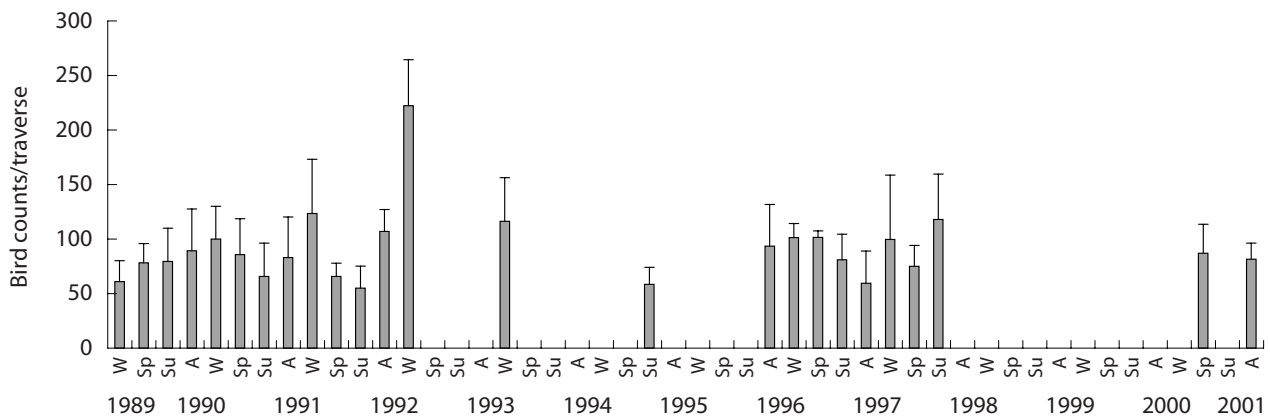
Figure 3. Summed bird counts in quarterly observation traverses along each of four tree belts on Payneham Vale. Error bars indicate standard deviations on the four traverses in one season. The X-axis indicates the seasons (W = winter, Sp = spring, Su = summer, A = autumn) of each successive year (across top). Absence of a column indicates that the traverses were not undertaken in that season. Note that the winter traverses have been notably higher than most other seasons. The counting technique ignores the many birds that do not generally use the tree belt, but might be visible in the paddock — this includes large numbers of swallows and tree martins, among other birds. This was because the project originally sought to document the role of the tree belts in attracting birdlife. Many insectivores are present in the farm bird list (see Appendix 4). Rita Watkins, whose support is gratefully acknowledged, collected all traverse data except the last two seasons. Beryl Walker collected the last two seasons.

Bird numbers were counted in four tree belts across the property. Individual season-to-season changes (Figure 3, main report) suggested an annual cycle, with a slight maximum in total bird numbers over winter, and this can be demonstrated statistically by consolidating and comparing the data for each season (Figure A4.1). Significant differences also existed between the four tree belts (Table A4.1). Small linear variations in the lengths of these belts appear to account for a major proportion of the variations in bird numbers in each belt, although probably not all of the differences.

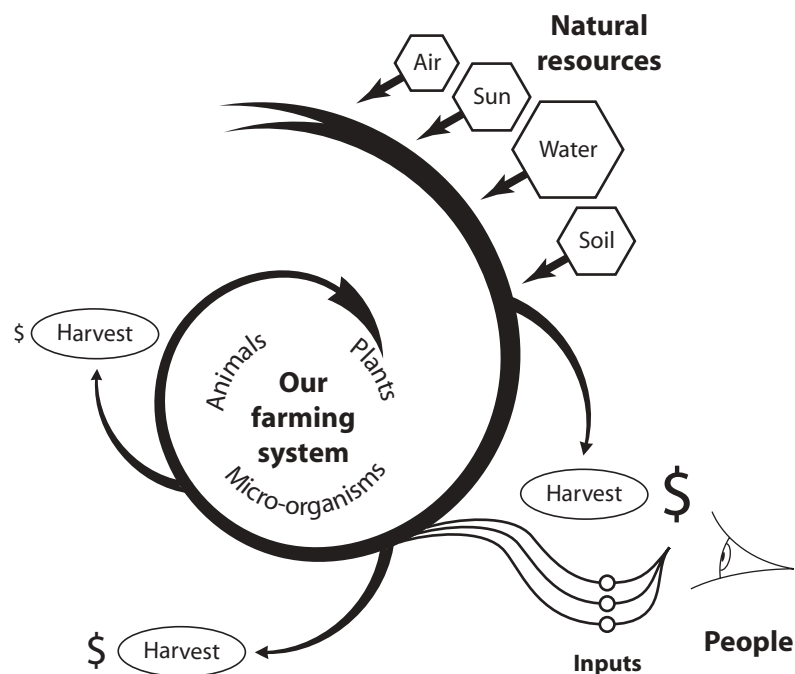
Figure 4. A farming system involves a cyclical process with contributions from eight resources (air, sun, water, soil, plants, animals, micro-organisms, people) for successful operation. In the ecosystem farm management concept, people apply interventions to guide the system, with control over water (the resource most out of balance) most critical to success.

Water is, in fact, seen as the most limiting of the resources depicted in Figure 4. The situation of occasional oversupply of water is worth analysing: it creates a hazard in crop establishment and flood peaks in the watercourse, as well as erosive loss of topsoil. Not only does this situation suggest lowering the gradient of drainage (a feature of keyline channels), but also that shifting the availability of water to other times wins in both conditions/times: both when flooding and waterlogging would prevail and in the normal conditions of water shortages.

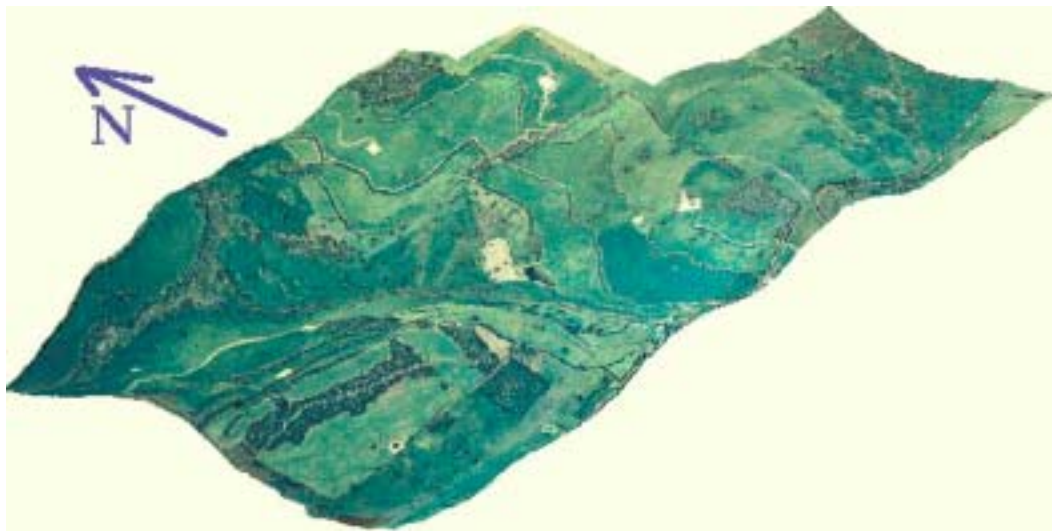
Figure A1.2 Ortho-drape of the aerial photograph of the property over the local topographic surface. North is to the top left corner, as a diagonal across the image. Bear in mind that the surface on which the photograph has been draped has an exaggerated vertical scale compared to the horizontal scale. As with many properties, a resource protection strategy of leaving vegetation on high ground and along creek lines has been practised during early clearing. Revegetation has mostly introduced the narrow belts of trees below the grade-drains. These are seen meandering around the landscape, approximately on the valley contours. A central, salinised area (to the NE of the cream-tinted dry paddock) can be seen to be a convergence of flow from the SE and E in the middle of the property.

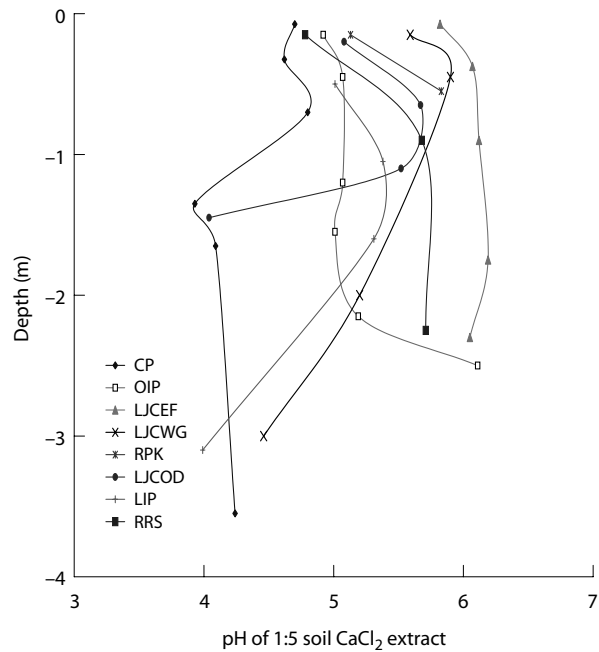
Figure A1.6 Acidity analyses of profile samples collected during installation of a set of eight monitoring bores on the Payneham Vale property.

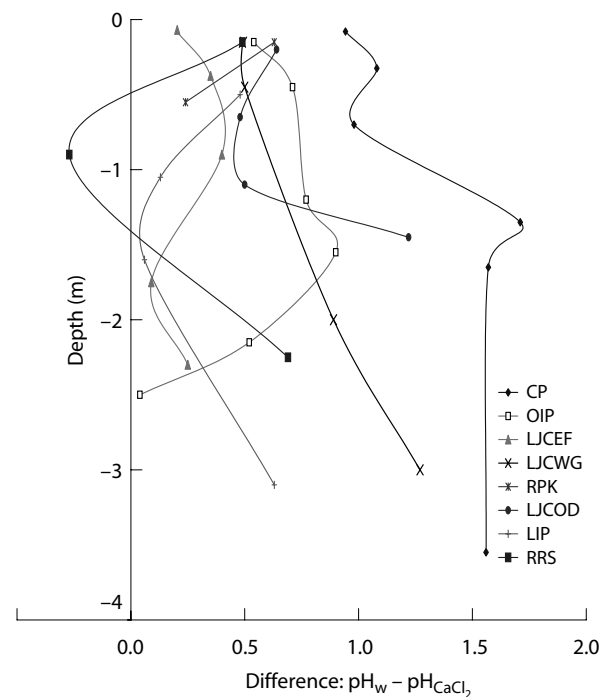
Figure A1.7 Difference of $\text{pH}_w - \text{pH}_{\text{CaCl}_2}$ analyses of profile samples collected during installation of a set of eight monitoring bores on the Payneham Vale property.

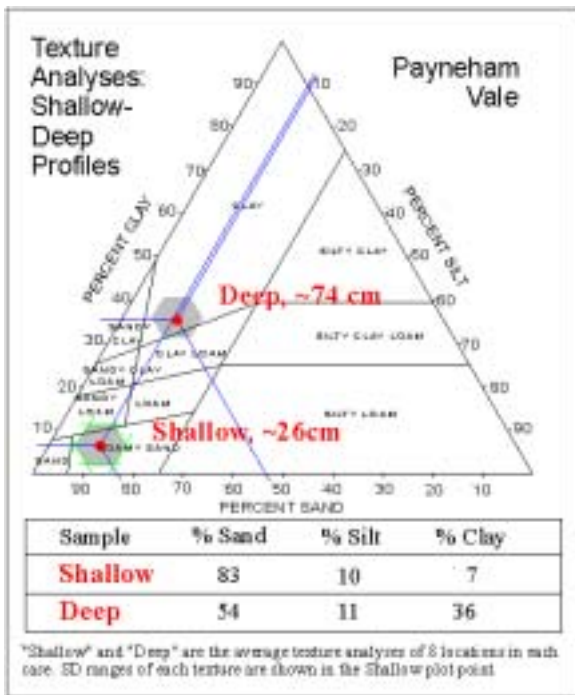
Figure A1.3 Texture analyses of paired surface and subsurface samples collected during installation of a set of eight monitoring bores on the Payneham Vale property. Tabulated data show the mean proportions of sand, silt, and clay plotted in the texture triangle. The standard deviation ranges of the two groups of data are depicted graphically, forming hexagons. It can be seen that the two groups of samples from deep and shallow depths are significantly different in their textures.

The success of the grade-drains and dams in capturing and removing surface water relates to the prevalence of subsoil material with lower hydraulic conductivity than the surface solum. The consequence of this arrangement is that infiltrating water typically moves laterally downslope in the subsoil, a widely occurring behaviour. This has been demonstrated by texture analysis of surface and subsurface materials (Figure A1.3). The literature on infiltration rates of such materials suggests that the

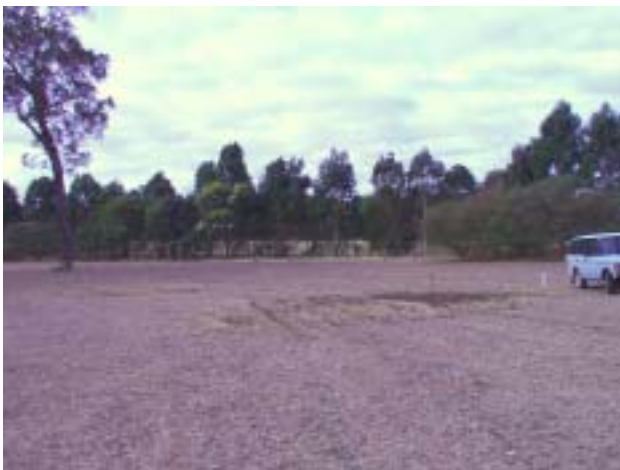
Figure A1.8 The Rocky Ridge South bore is monitoring the development of this saline outbreak, here fringed with barley grass.

Groundwater-monitoring bores were installed, with collection of soil profile materials on several locations around the property. Soil moisture profiles were obtained on recovered profiles (see Figure A1.8, Appendix 1), and demonstrated the point mentioned earlier concerning the dryness of the subsoil zone. The new monitoring bores supplement an original set that was established in 1996. Groundwater depths have been periodically monitored in the established bores and show a typical late-summer decline and late-winter rise. The hydraulic conductivity of most of the monitoring bores has been examined by ‘slug’

The long-term discharge of saline water through profiles tends to convert clays in the permeable material from calcium clays to sodium clays. This soil property is known as sodicity. It is a soil condition that can be investigated by examining the change in acidity of a soil:water slurry when a small aliquot of soluble calcium is added, a technique discussed by McArthur (1991). A sodic clay will be more alkaline in such conditions, because the sodium ions displaced into solution create a stronger base. Only one sample (RRS = Rocky Ridge South) reaches this condition (Figure A1.7). This response is clearly due to a localised groundwater discharge, also evident as a barley grass-fringed bare patch adjacent to this monitoring bore (Figure A1.8).

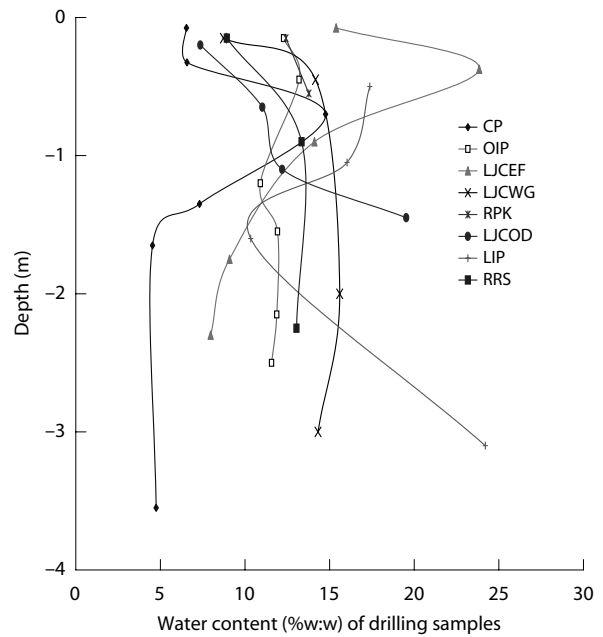
Figure A1.4 Gravimetric water content of samples collected during installation of a set of eight monitoring bores on the Payneham Vale property.

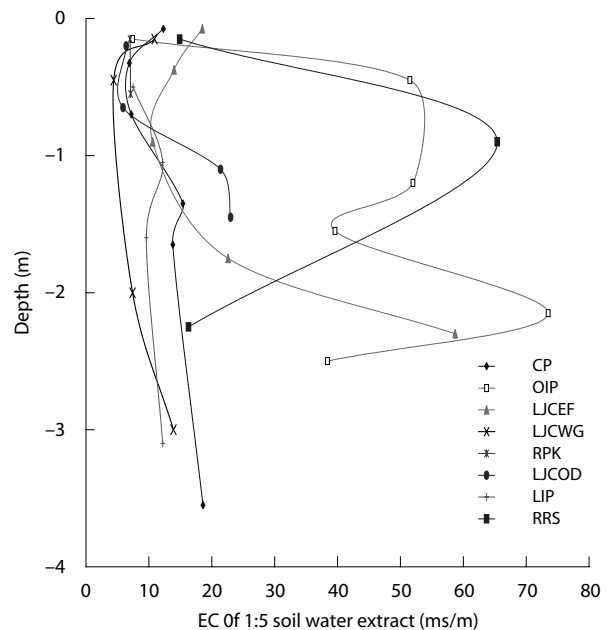
Figure A1.5 Electrical conductance analyses of profile samples collected during installation of a set of eight monitoring bores on the Payneham Vale property.

salinity below 2 m (Figure A1.5) reflecting the capacity of native vegetation to keep this hazard under control.

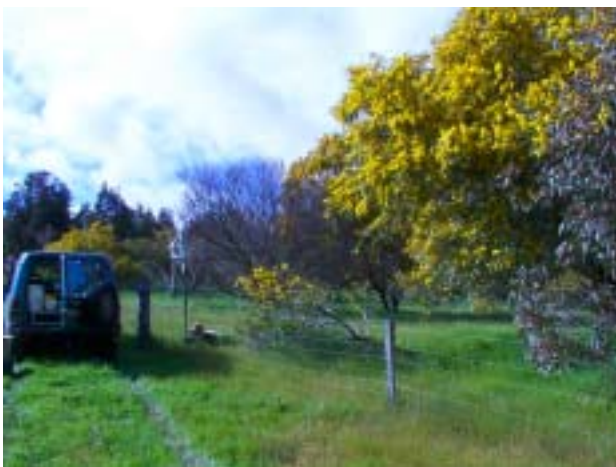
Figure A2.1 Weather-station monitoring the micro-climate conditions in a tree-belt location on the Payneham Vale property undertaken in this project. Wind speeds in this protected location were around five-fold lower than at a Bureau of Meteorology location in the Rocky Gully townsite (Table A2.1). Obviously, protection from exposure is a preference of many domestic and native species. This weather station also logs groundwater levels in a bore installed alongside it.

The Payneham Vale property enjoys a semi-arid Mediterranean climate with dry, moderately hot summers and cool, wet winters. As discussed in the Overview of investigations (main report), some conjecture has arisen as to whether the tree belts installed have moderated the weather conditions on the property. Comparisons of the recorded weather observations to those of the Frankland Vineyards and Rocky Gully weather stations were undertaken to consider this hypothesis. This comparison does not adequately address the capacity of a mobile organism to seek cover from exposure to wind, sun, or rain in the protection of the tree belts (Figure A2.1).

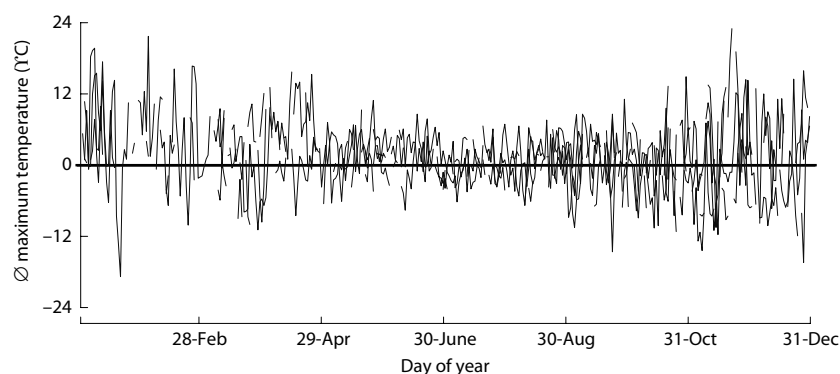
Figure A2.3 Differences in maximum air temperature between Payneham Vale and Rocky Gully. Data from mid-1996 to 2000 were consolidated to a single annual cycle to indicate the hourglass ‘envelope’ of range found with this comparison.

Maximum temperatures at Payneham Vale have been both substantially hotter and substantially colder than at Rocky Gully (Figure A2.3) although, on average, Payneham Vale is just slightly warmer (Table A2.1). There are occasional periods of several days when atmospheric conditions at the two locations are clearly different and maximum temperatures may be more than 12°C different — a significant value in that this is often

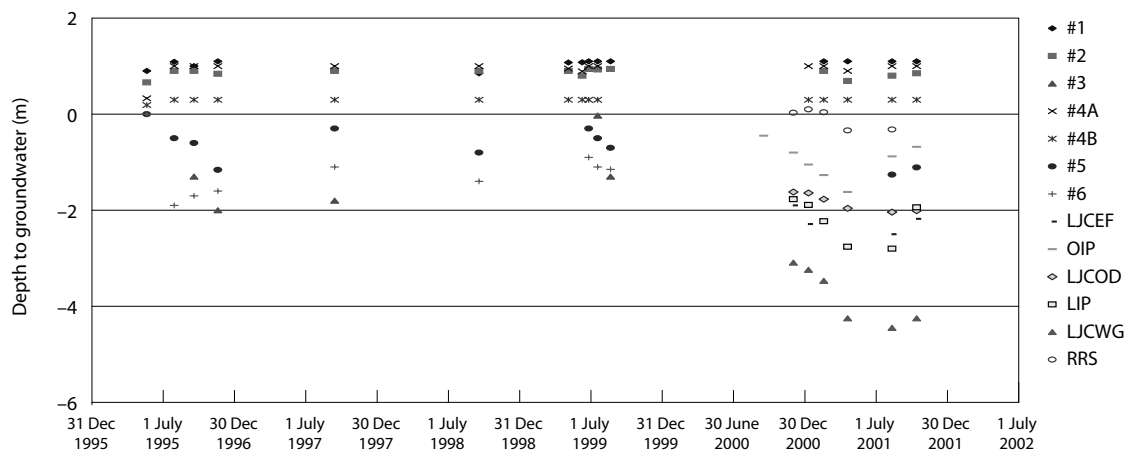
Figure A3.1 Groundwater levels in monitoring bores installed on the Payneham Vale property. Bores were installed in 1996 and 2000. This figure includes data for the major bores only; some three further were dry for most of the study period. Measures are with reference to the local ground surface as zero.

The calendar year 2001 was unusually dry, and water levels declined over the course of the 12 months of the study period (Figures A3.1 and A3.2). The mid-year low point in groundwater levels in 2001, depicted in more

Several of the bores initially installed in 1996 were along the valley creek line. These bores (numbers 1, 2, 4A and 4B) continue to almost always have water right to the top of the casing (and consequently they have positive depth readings in Figure A3.1). They demonstrate that pressurised, confined groundwater exists at their relatively shallow depths right along the watercourse. The groundwater in these holes is the most saline on the property (Table A3.1). The Rocky Ridge South monitoring bore (Figure A1.8), installed some distance from the watercourse in 2000, also transiently showed a positive groundwater pressure (Figure A3.1), but declined in a

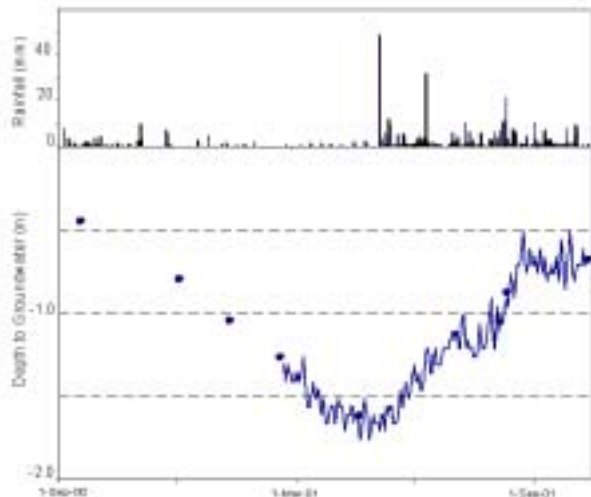
Figure A3.2 Groundwater levels in the Old Irrigation Paddock (OIP) monitoring bore. Rainfall data are from a weather station adjacent to the monitoring bore. This figure is a composite of manual measurements and continual logging (from mid-February 2001) of the one bore hole (OIP).

detailed monitoring of the Old Irrigation Paddock bore (Figure A3.2), appears to have rapidly responded to local rainfall. A similar, prompt mid-year jump from such a low point in the annual cycle of groundwater was observed in several bores continuously monitored over the dry sequence of years of 1994 to 1996 by Bartle *et al.* (2000) in studies in the neighbouring Kent River catchment.

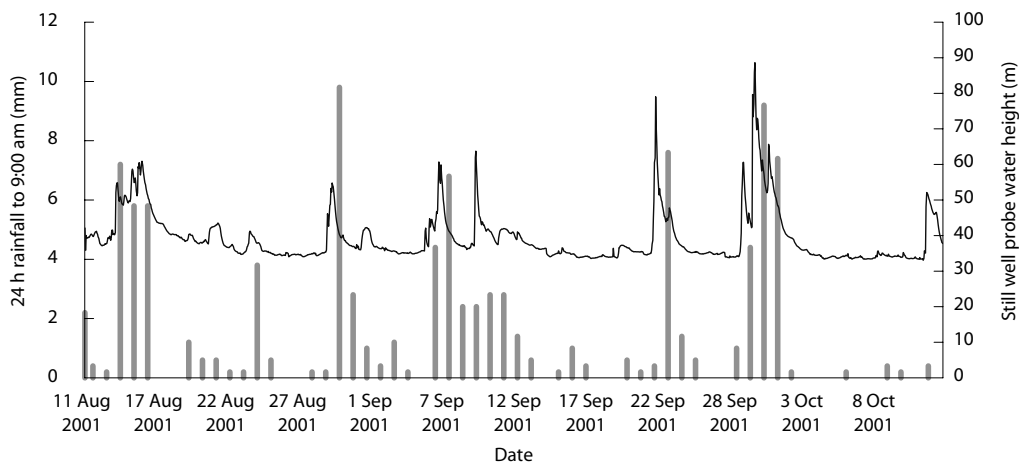
Figure A3.3 Stage height trace and recorded rainfall. Note that the nearby aquifer was basically full over this period (see Figure A3.2) and would be steadily discharging seepage.

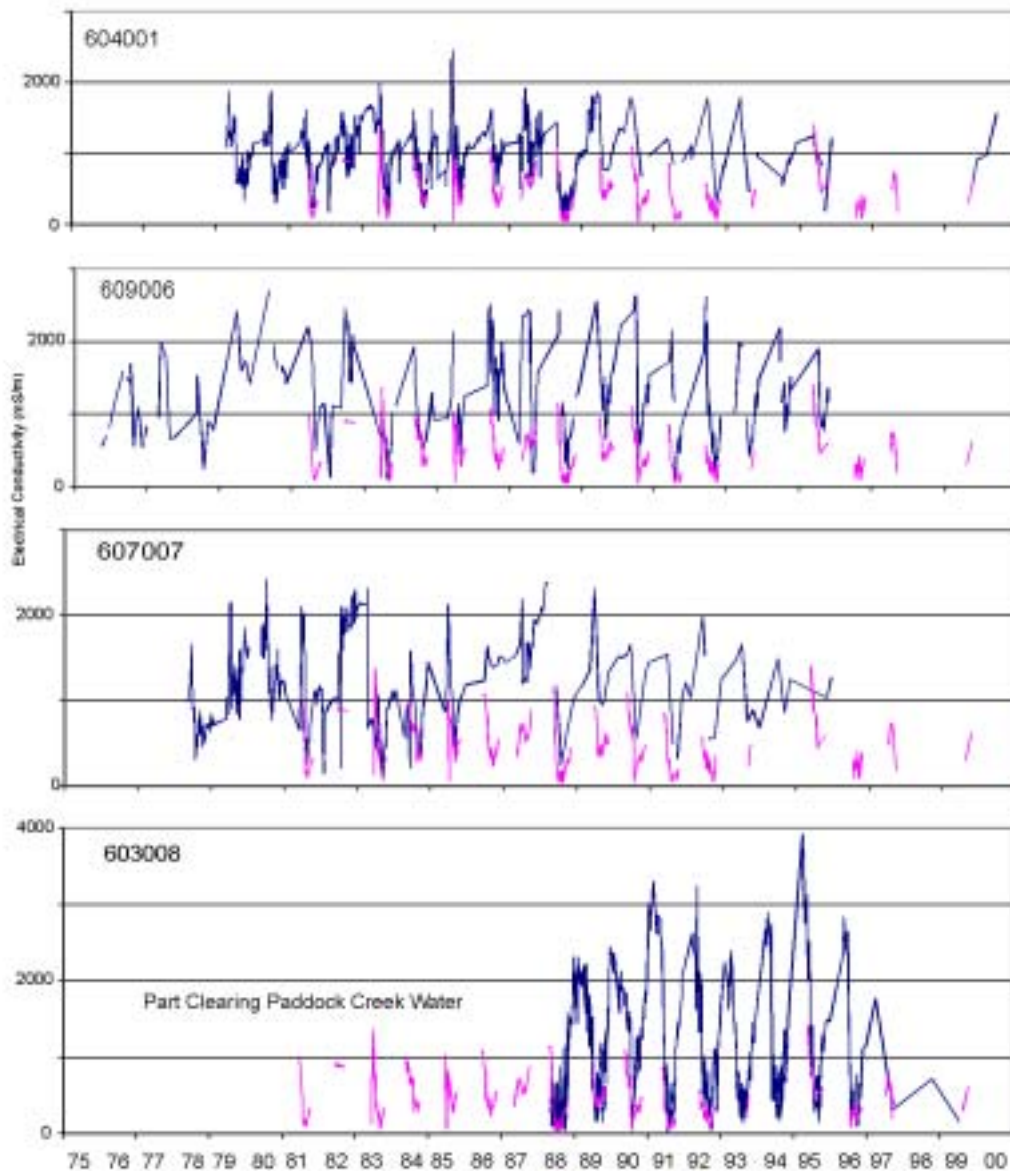
Figure A3.4 Comparison of the salinity of four regional creeks (dark blue) with that at the Part Clearing sample point of Payneham Vale creek (magenta, replicated in each of four traces). The four Waters & Rivers locations 603008, 607007, 604001 and 609006 are shown in Figure A2.2.

Fortunately, such poor water so late in the season is rare (Figure A3.4). The long-term salinity of the surface water in the Payneham Vale creek was compared to the Water & Rivers data for the region. Figure A3.4 compares surface-water salinity observations at the Part Clearing Paddock Creek site on Payneham Vale with four external locations

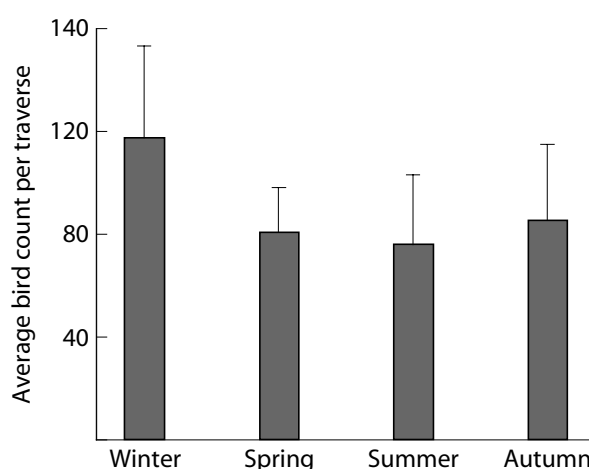
Figure A4.1 Annual cycle in bird numbers in the Payneham Vale tree belts. Data are the averages (error bars = standard deviation) of four tree belts visited on six separate occasions (spring, summer, autumn) or seven separate occasions (winter) from 1989 to 2001. An analysis of variance of all bird count data found that:

- bird numbers differed significantly between seasons ($P = 0.00034$)
- bird numbers differed significantly between tree belts ($P = 0.01950$)
- there was no interactive effect of these two factors (seasons and tree belts) numbers of birds present ($P = 0.8400$).

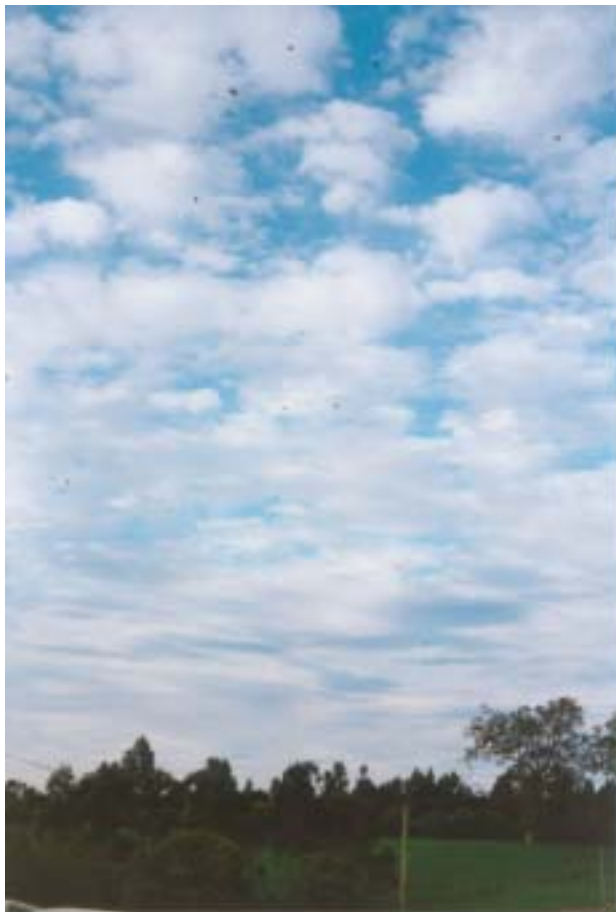
Figure A4.2 Tree martins collecting insects in the early evening. Difficult to photograph, but close inspection of the original photograph suggested that there are around 20 birds in the sky in this image. One perhaps inconsistent indicator that resulted was bird lime on vehicle window and bonnets.

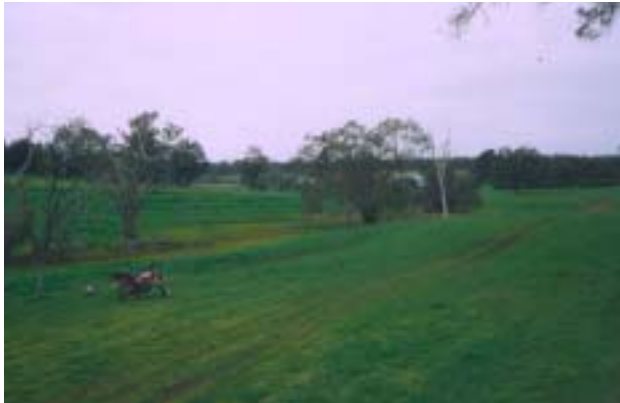
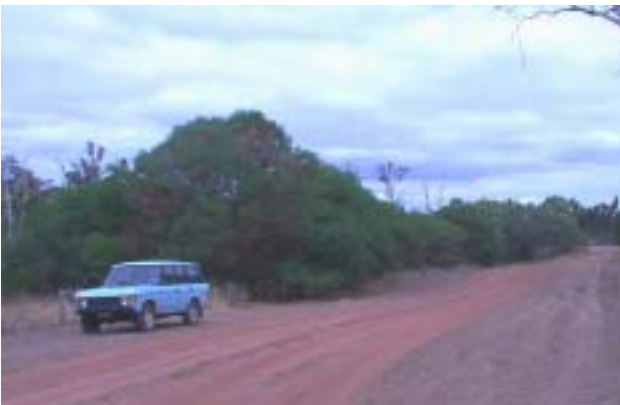
Figure A5.1 (above) Development of revegetation protecting the main watercourse. On the Payneham Vale property, protection of the watercourse has largely been through the growth of new plantings. Older, mature trees, such as the one at top right, that showed thinning canopies in August 1991 have continued to decline, and died in the next few years. Other examples of declining trees are a tree to the left of the dead forked tree, itself right of centre, and a further tree seen over the vehicles, somewhat obscured in the later image by the vigorous growth of the fenced trees.

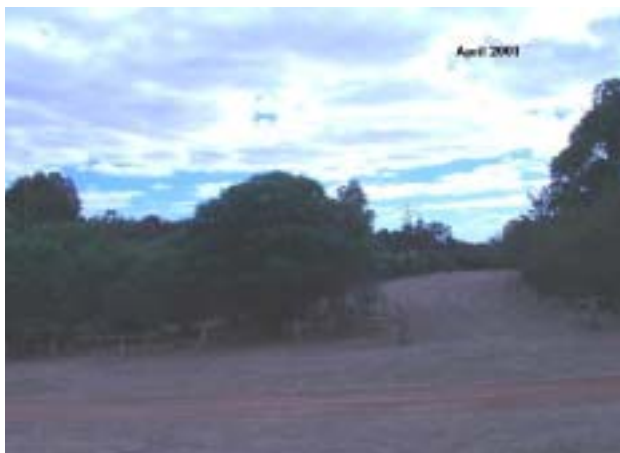
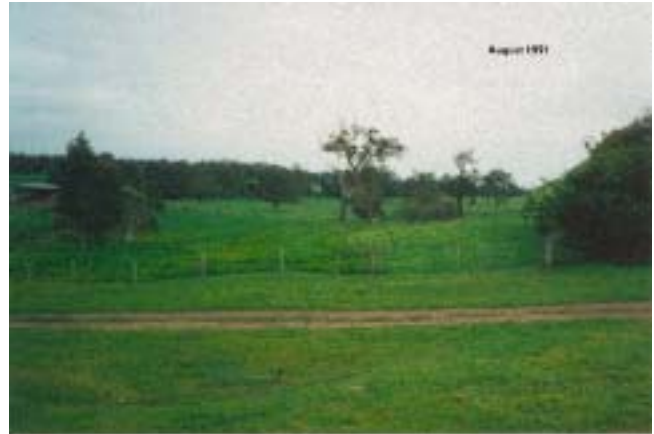
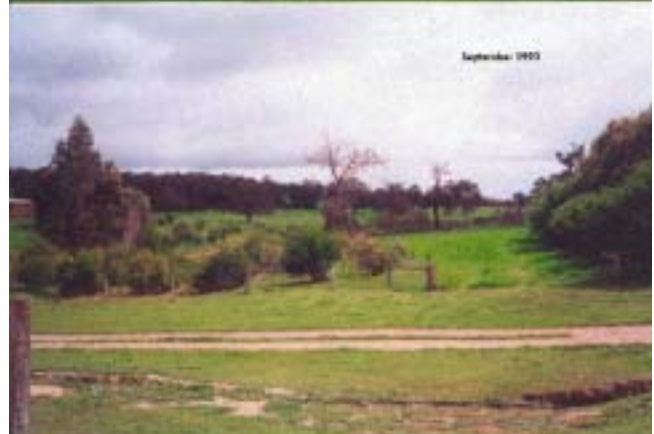
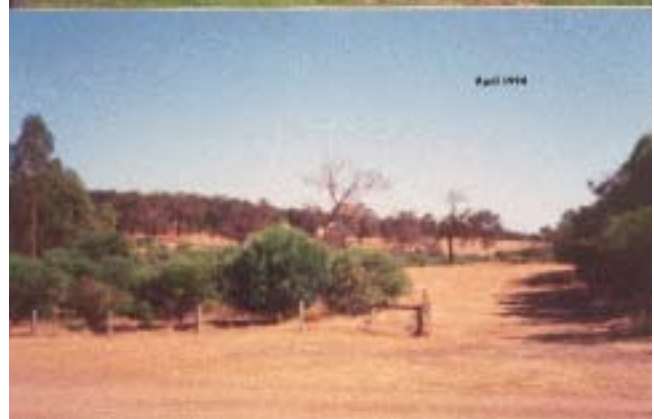
Figure A5.2 (above and left) Series of four photographs taken while standing on the bank of the House Dam and looking north, showing the development of vegetation and consequent protection of the watercourse. The House Dam is dam D in Figure A6.2, Appendix 6. (Photo credits: 1991–1994, Watkins; 2001, GHEM.)

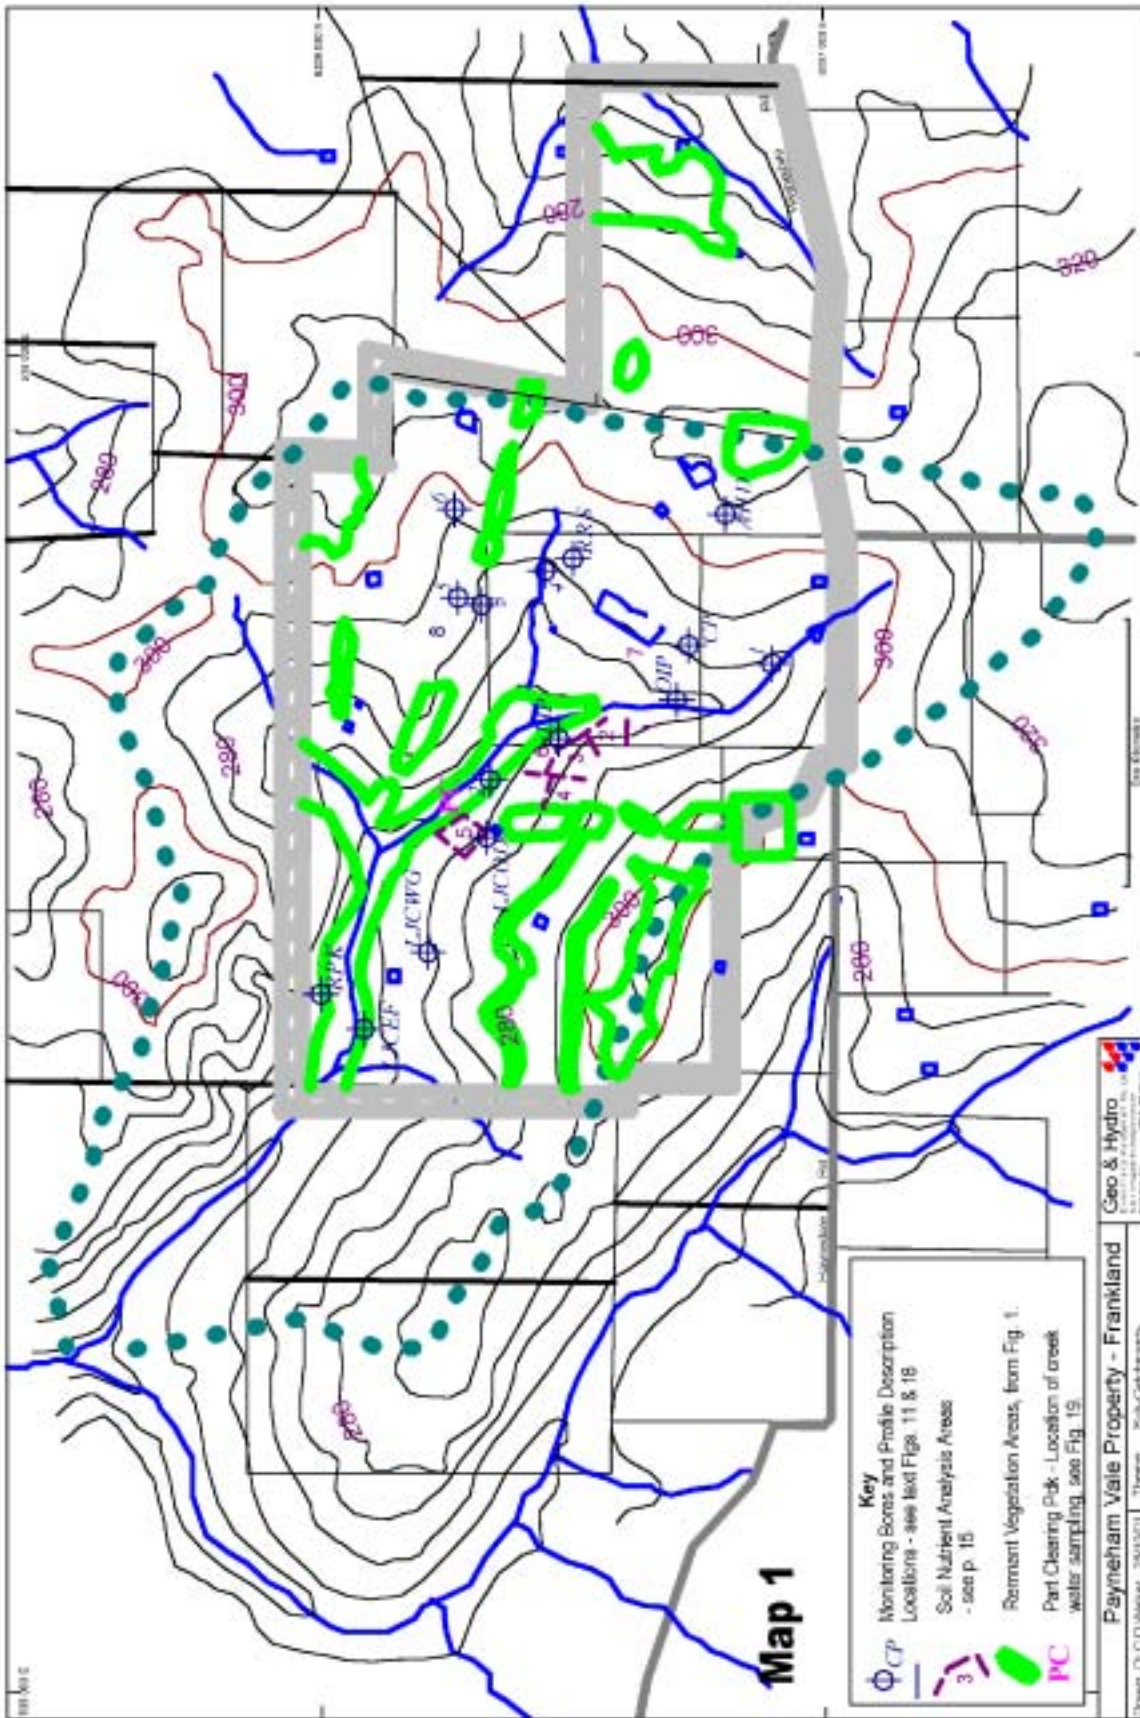
Figure A6.1 Map of Payneham Vale property showing monitoring bores and profile description locations, soil nutrient analysis areas, remnant vegetation areas and part clearing paddock.
